FLOOD PLAIN MANAGEMENT STUDY

HABERSHAM COUNTY, GEORGIA

FLOOD PLAIN MANAGEMENT STUDY
for
HABERSHAM COUNTY, GEORGIA

MARCH 1986

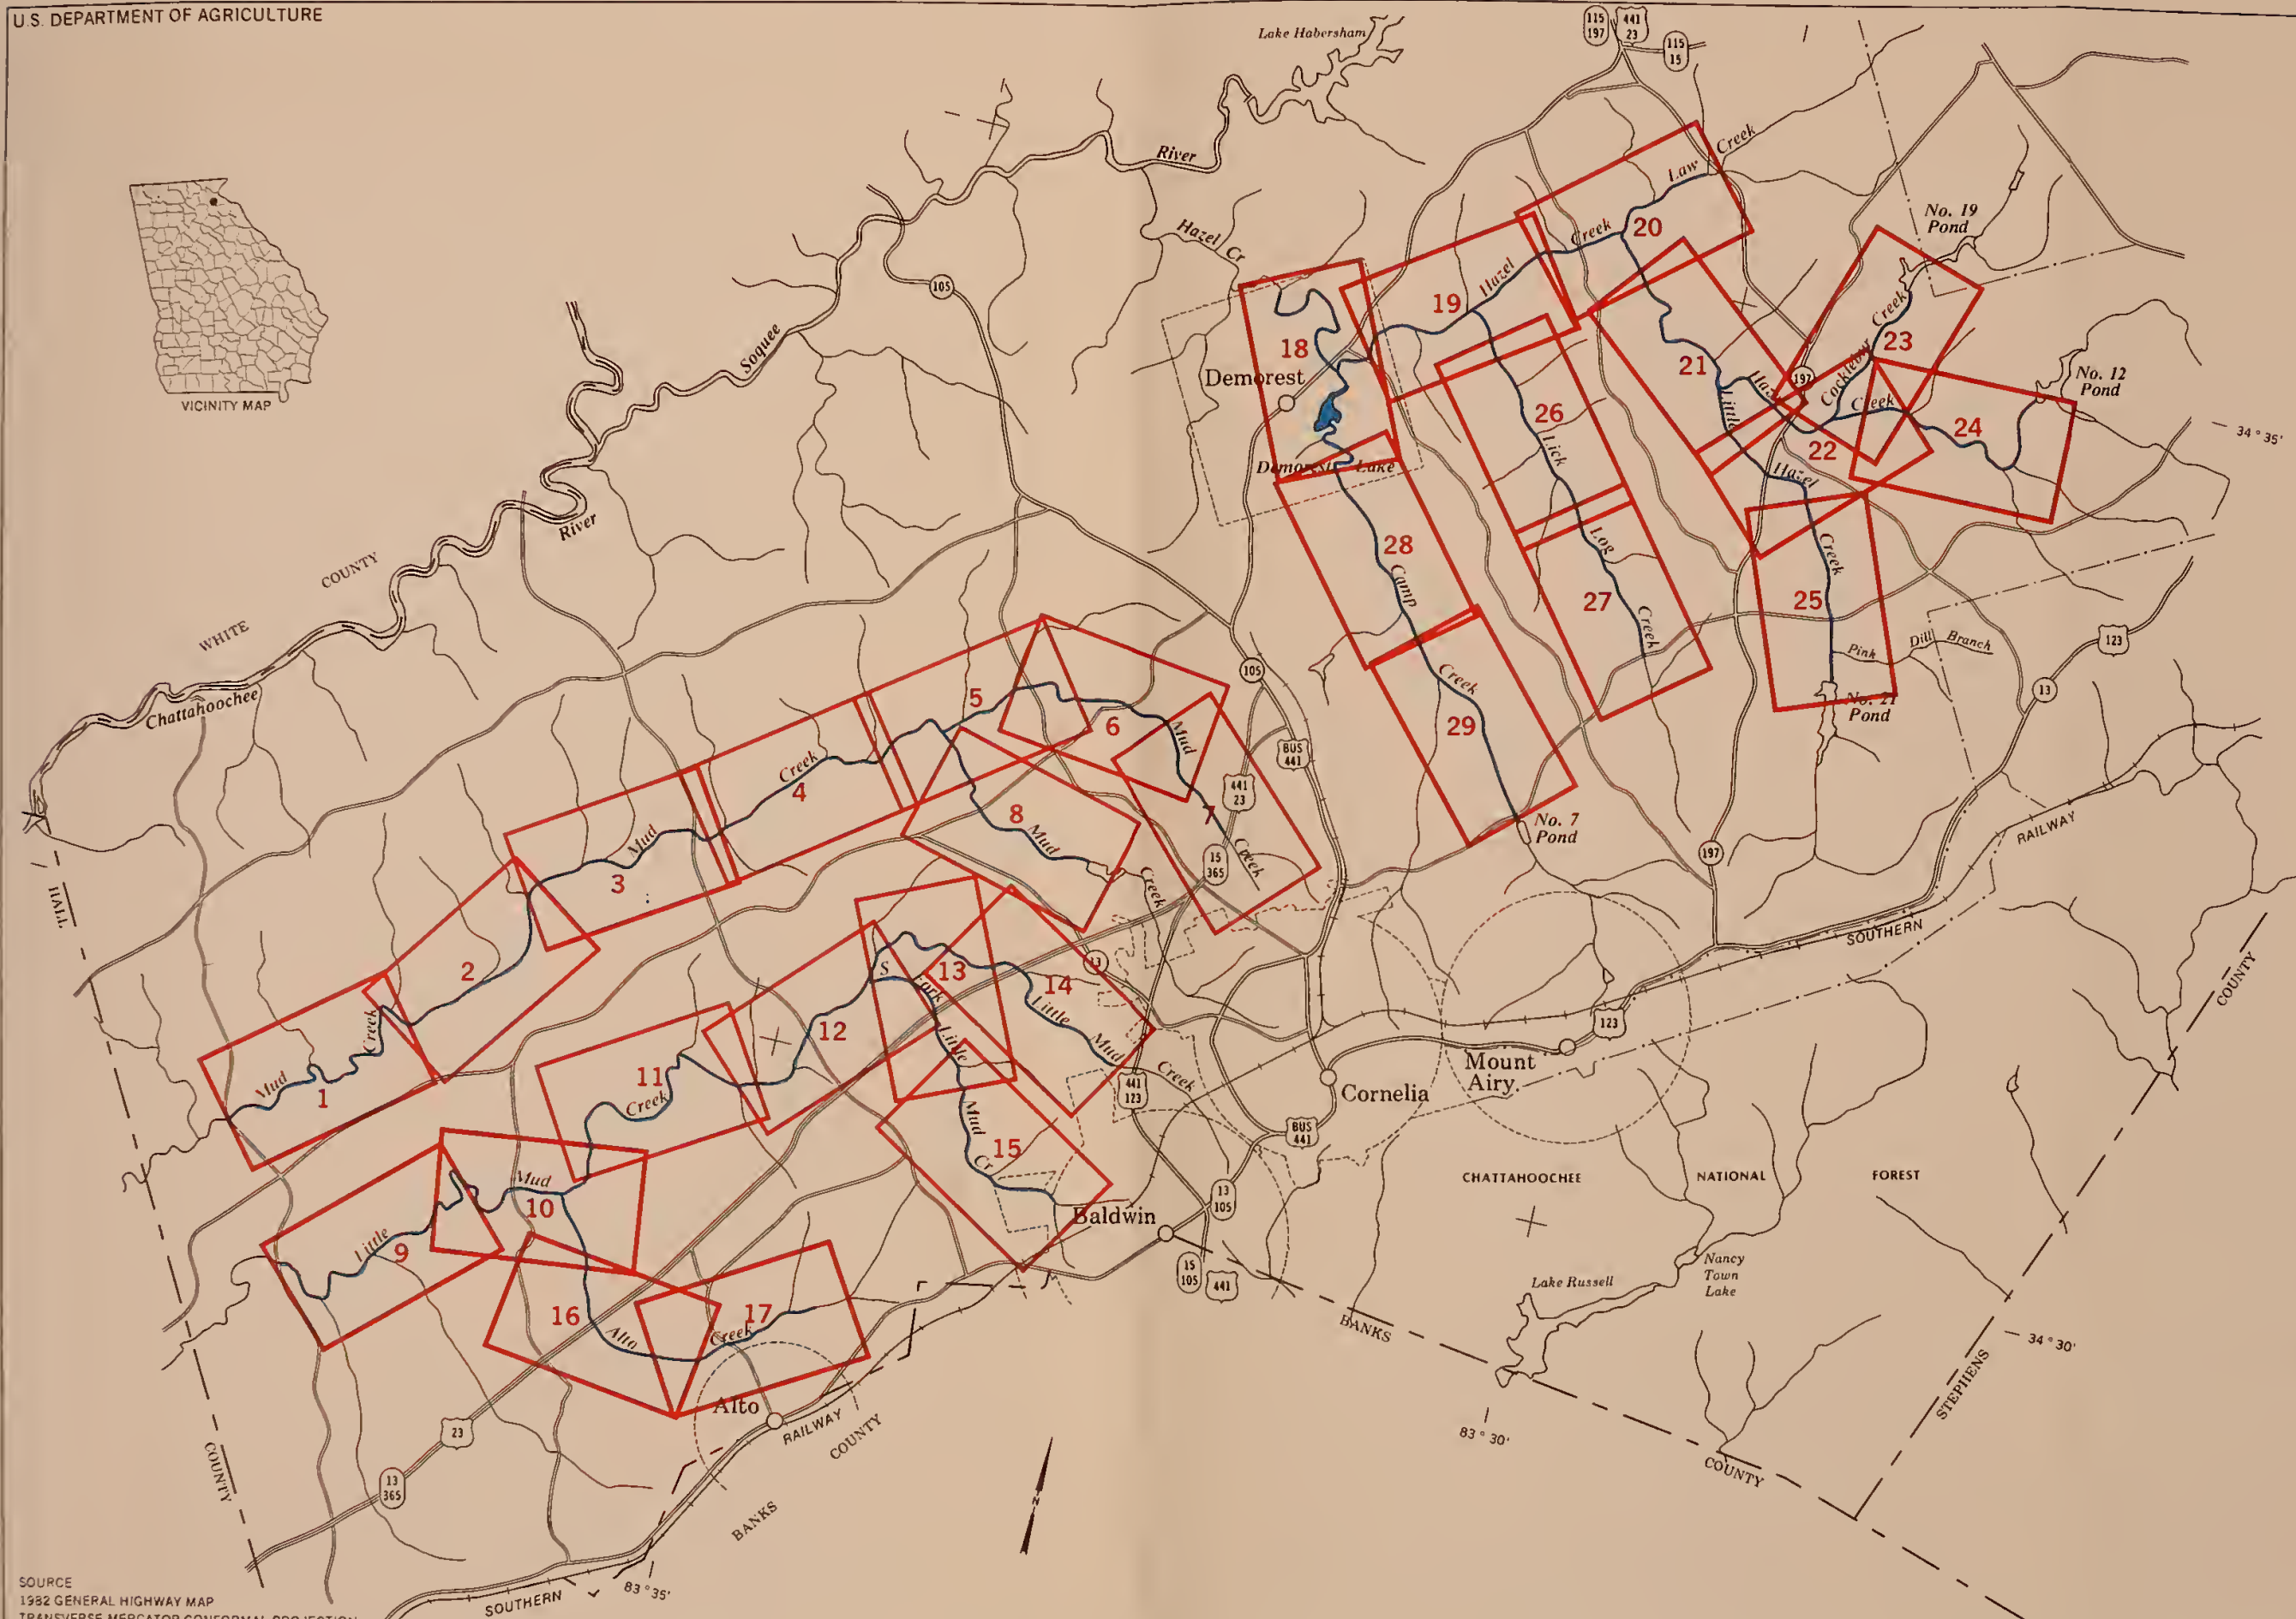
**PHOTO MAP INDEX
HABERSHAM COUNTY
FLOOD PLAIN MANAGEMENT STUDY
GEORGIA**

The flood hazard area photomaps which follow this section can be used to identify the 100-year and 500-year or dam breach flood hazard areas.

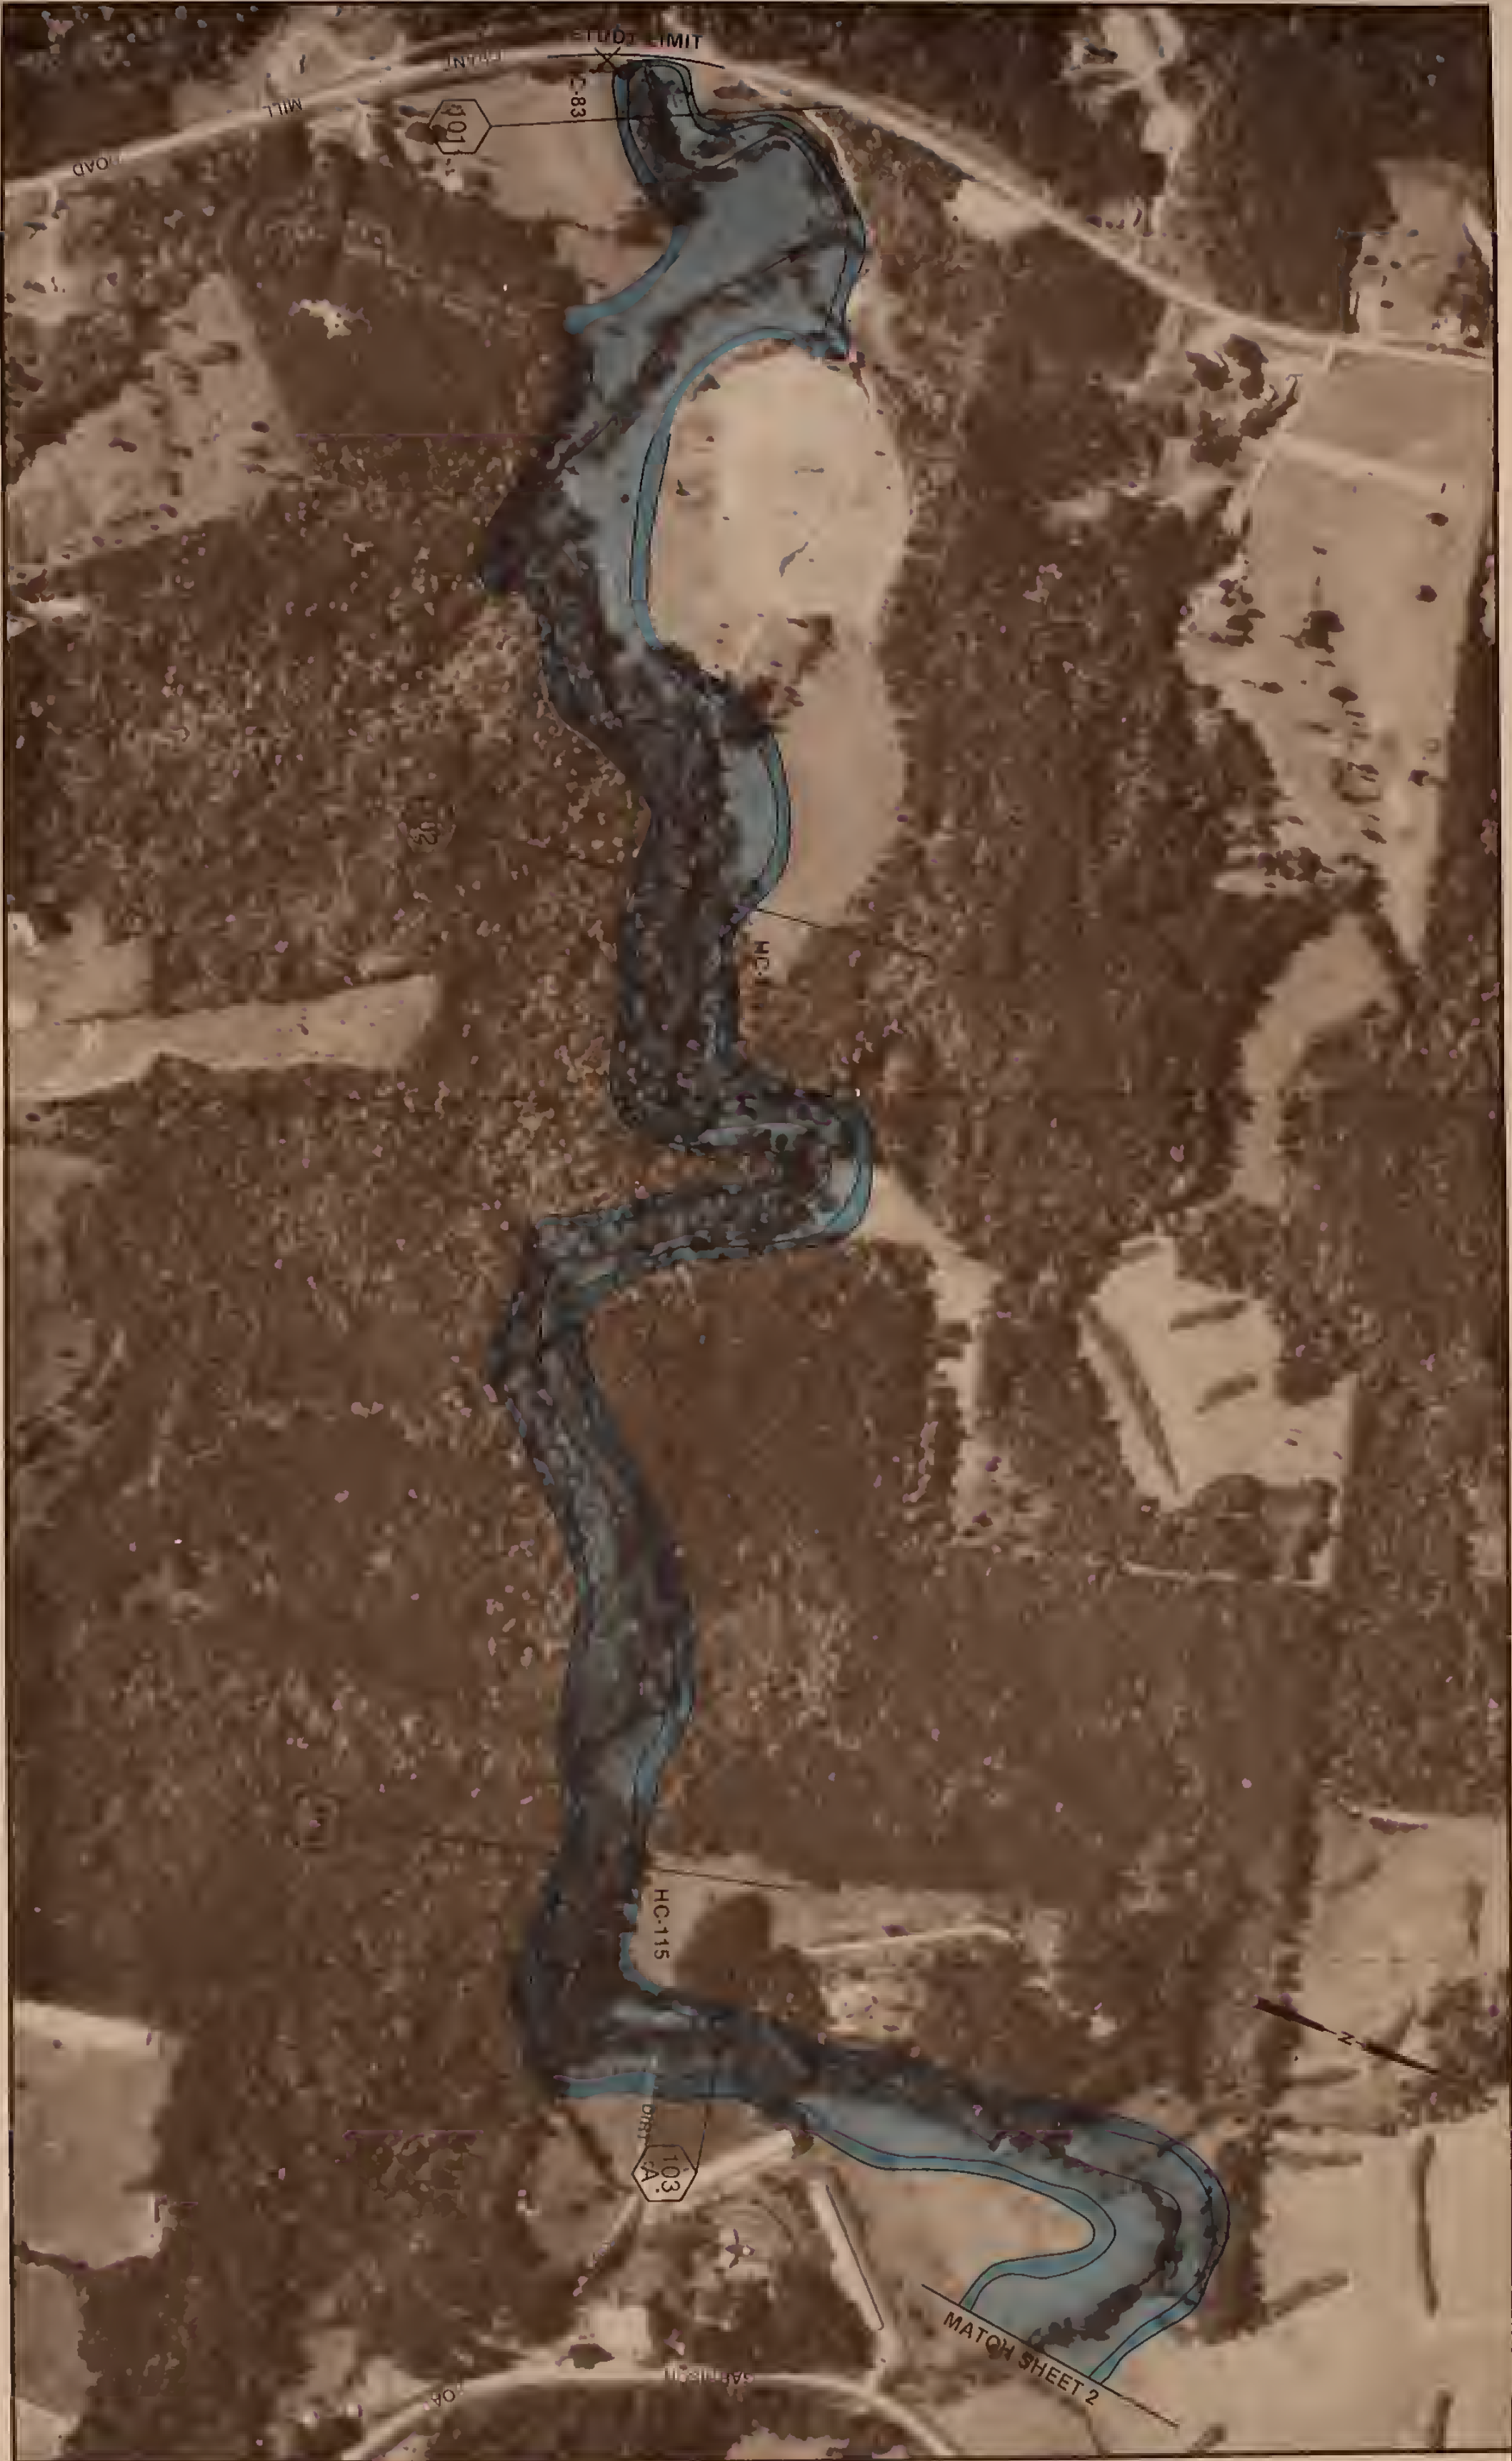
100 Year Flood Hazard Area

500 Year or Dam Breach Flood Hazard Area

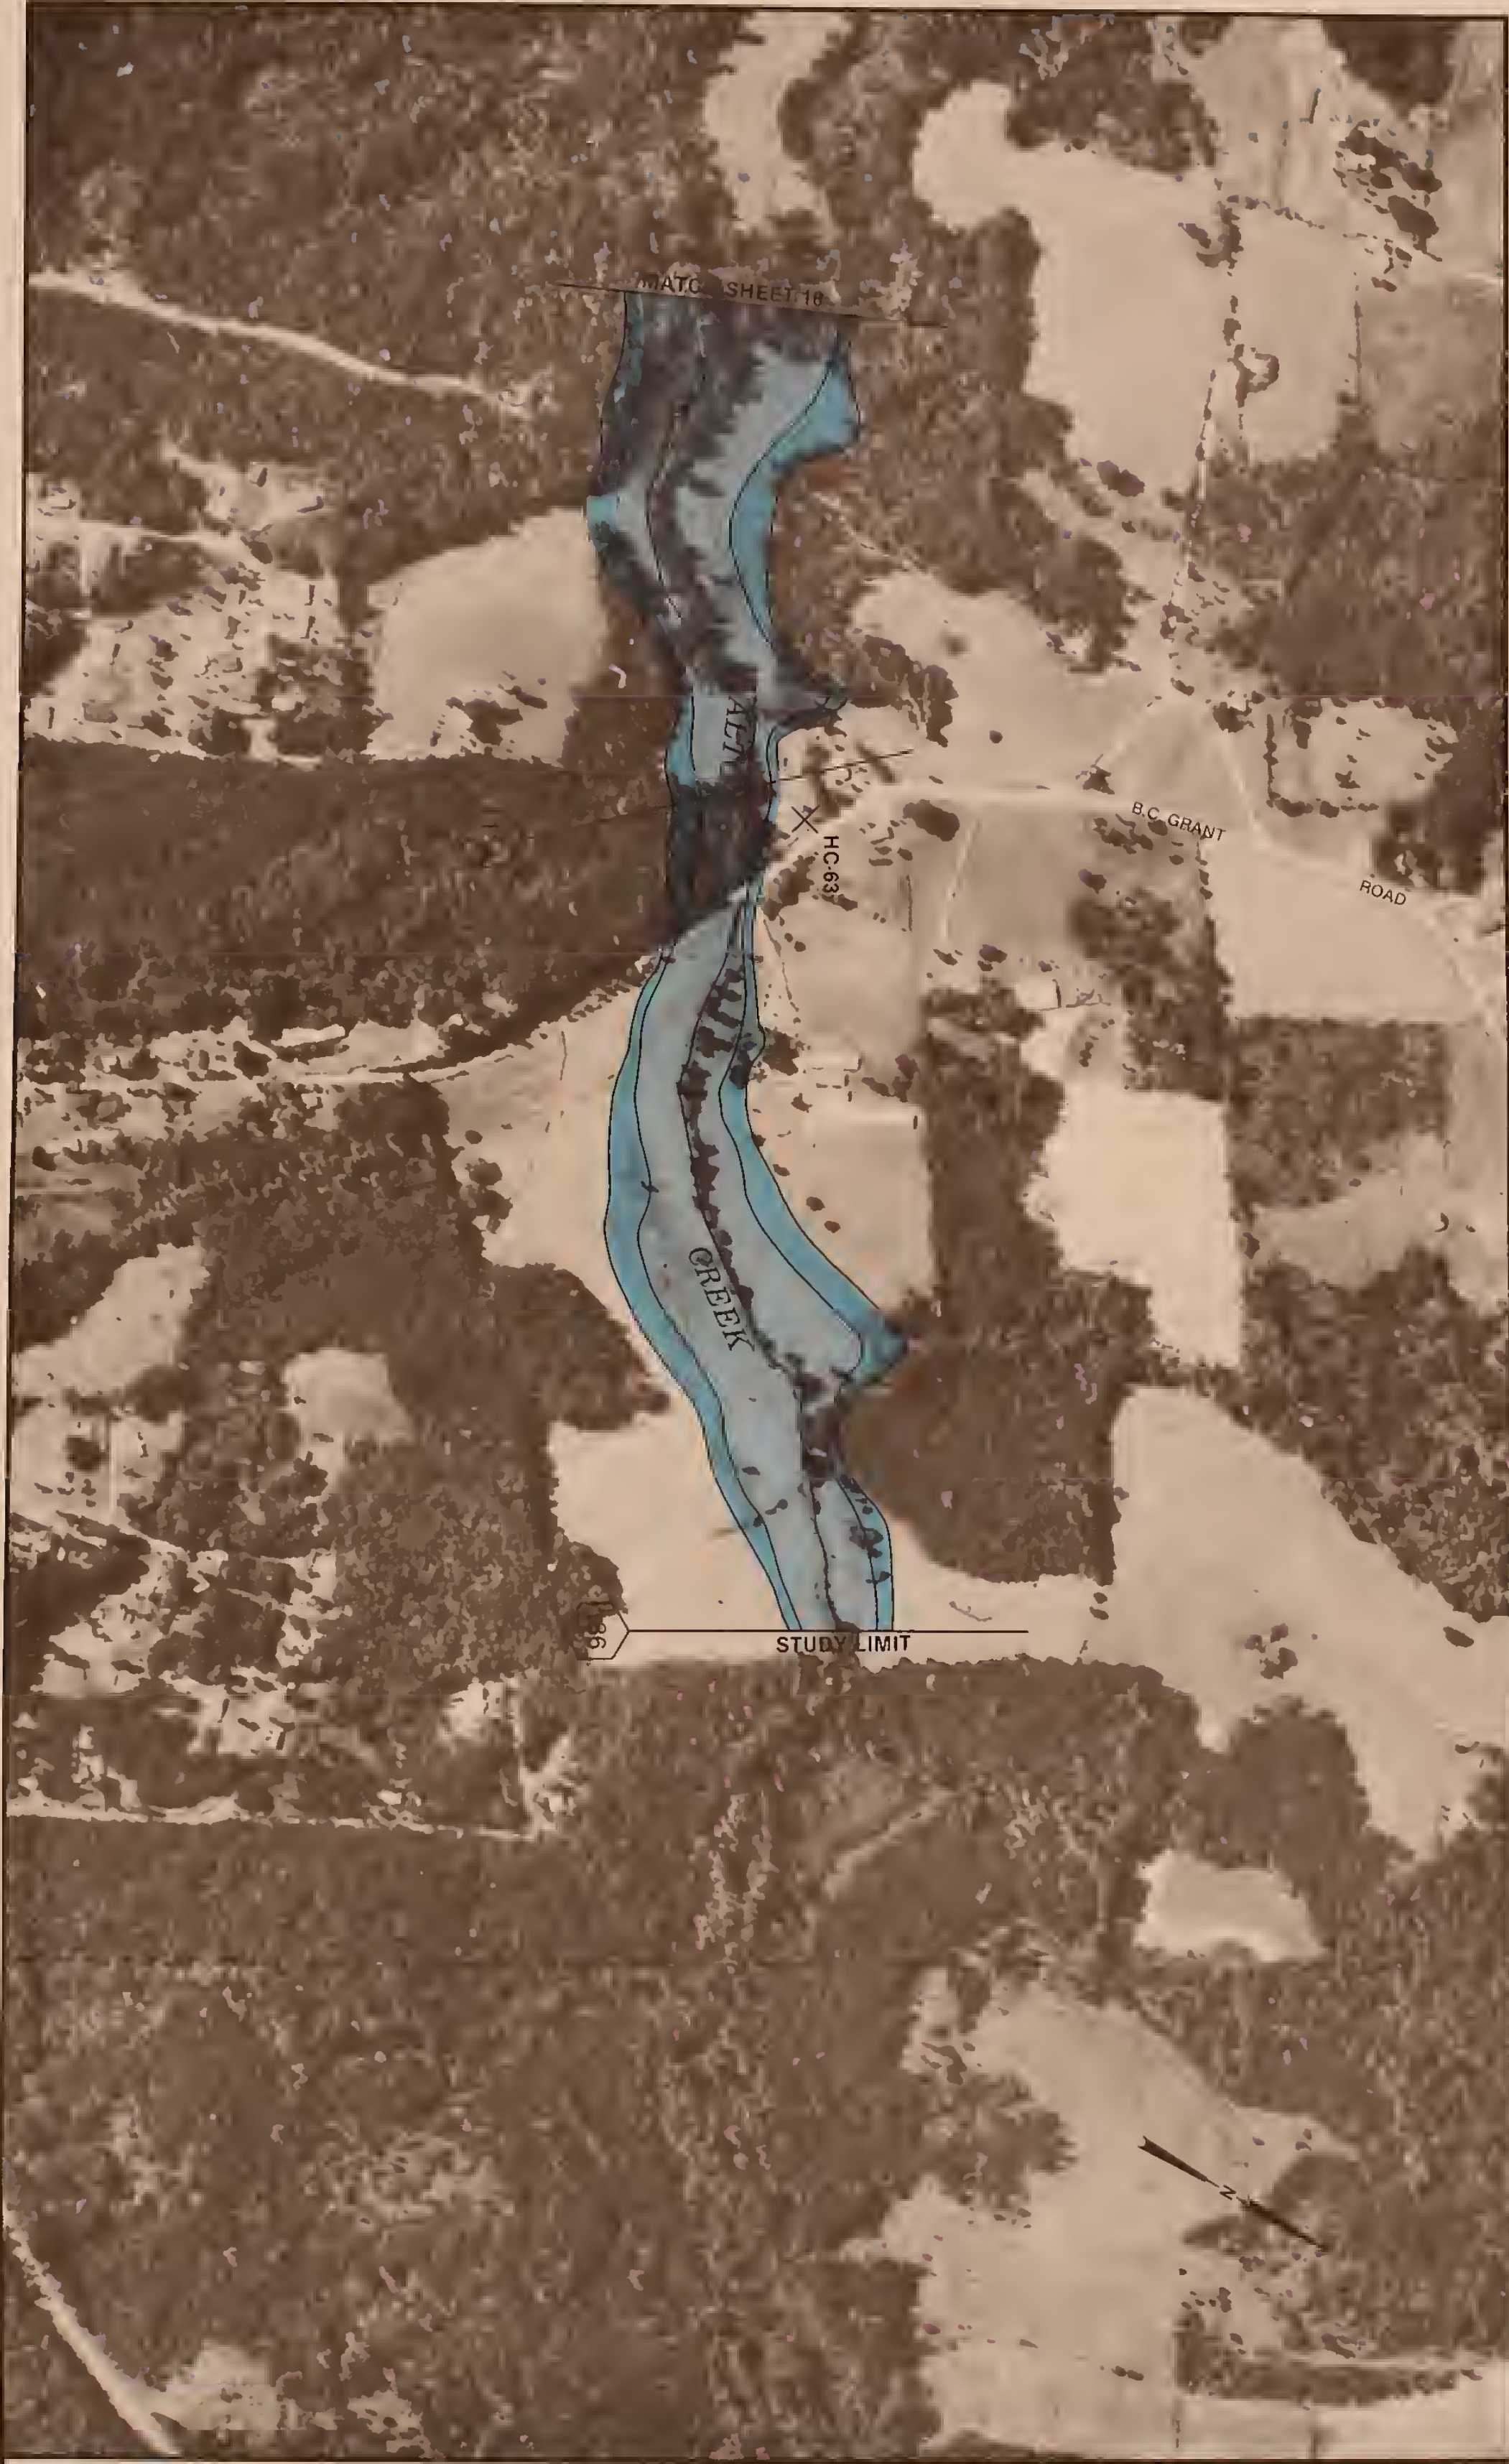
SHEET 13 OF 29	U.S. DEPARTMENT OF AGRICULTURE SOIL CONSERVATION SERVICE HABERSHAM COUNTY FLOOD PLAIN MANAGEMENT STUDY HABERSHAM COUNTY, GEORGIA	FLOOD HAZARD AREA
		HAZEL AND CAMP CREEKS

FLOOD HAZARD AREA
